Guided Bus Crossing at Fen Drayton Lakes

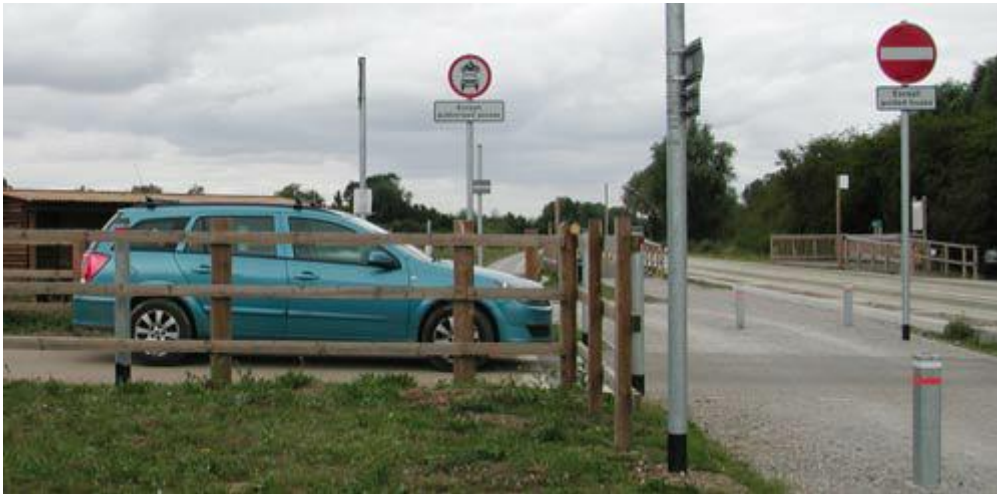
This view shows the fence rail at window height of my Astra Estate.

Land Rover or 4x4 vehicles are higher and the driver can see over the rail with no problem.

“Having reviewed the junction myself I don't consider that the fence represents a significant obstruction to visibility. As your photographs illustrate a cyclists would be seen through the fence rails.

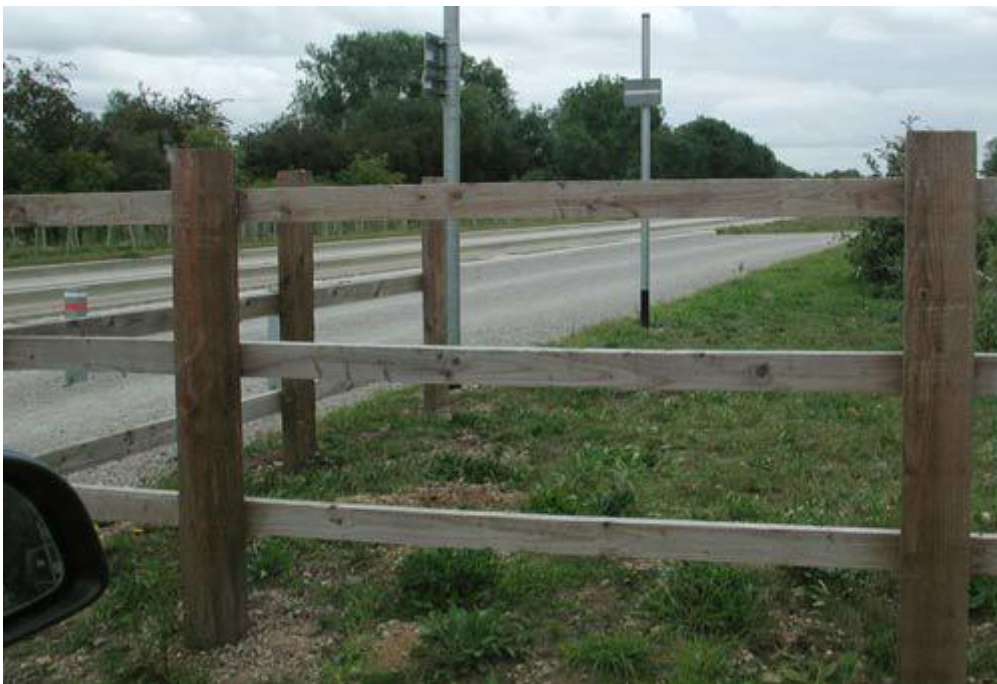
This is the view from the drivers seat with the car at the white line on the road.

The bus team are suggesting that we first look through the fence for cyclists or possibly vehicles, galloping horses etc on the maintenance track. If clear we then move forward to a position where it is possible to look down the track to see if a bus is approaching.

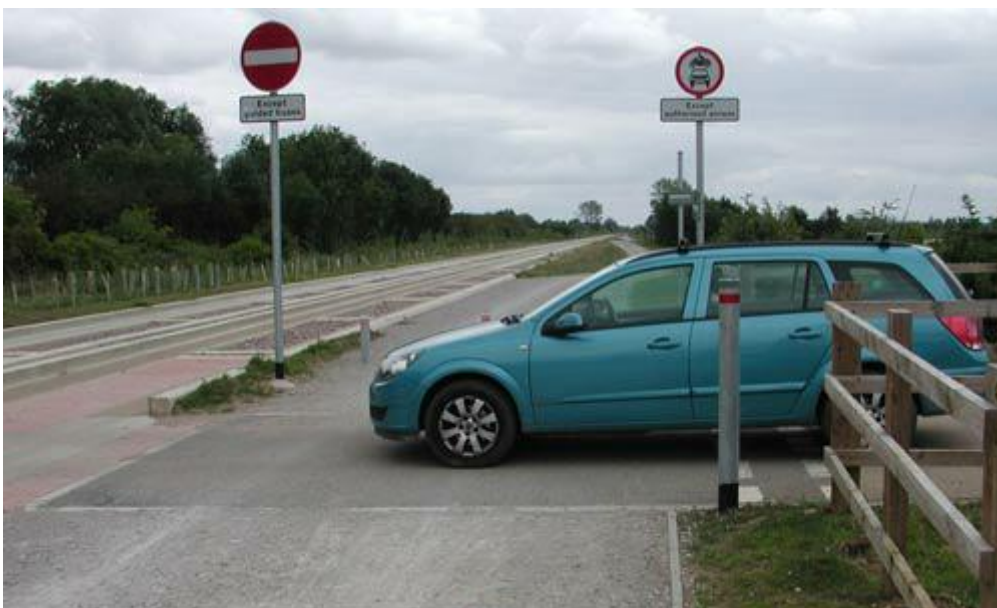
This is the first point where a clear view is obtained along the track. (It is possible to stop a little further back and look between the post and the rail but I suggest you would only do that if familiar with the junction)

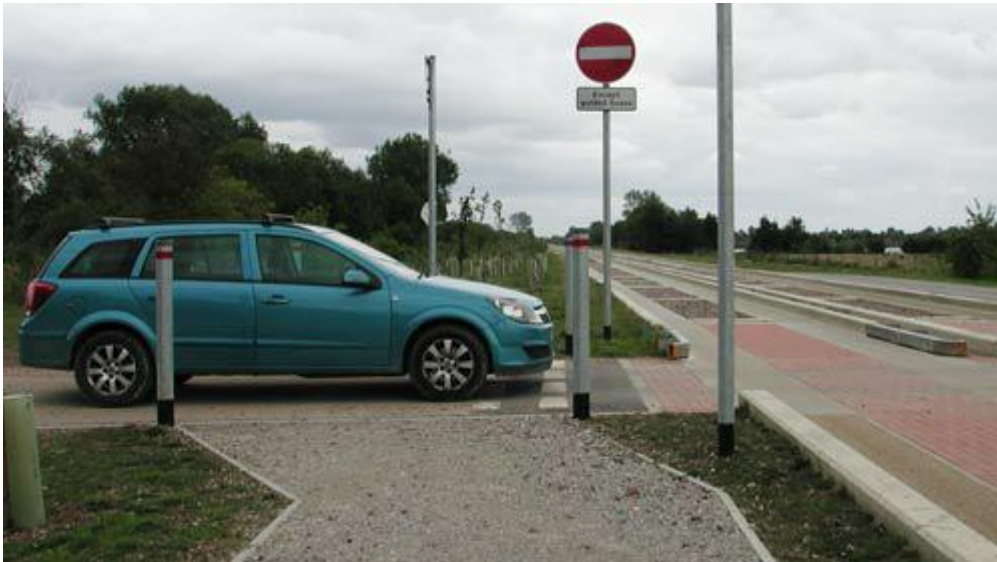
View travelling South with the vehicle at the stop line. The newly planted trees are putting on growth and already blocking the view. They will not be removed until the Autumn so the obstructed view will continue until then.

I agree that some of the trees on the opposite side will restrict visibility when they grow. We will therefore be removing those closest to the guideway in the Autumn and using them to replace trees which have died elsewhere. I apologise that this information wasn't included in the earlier response.”

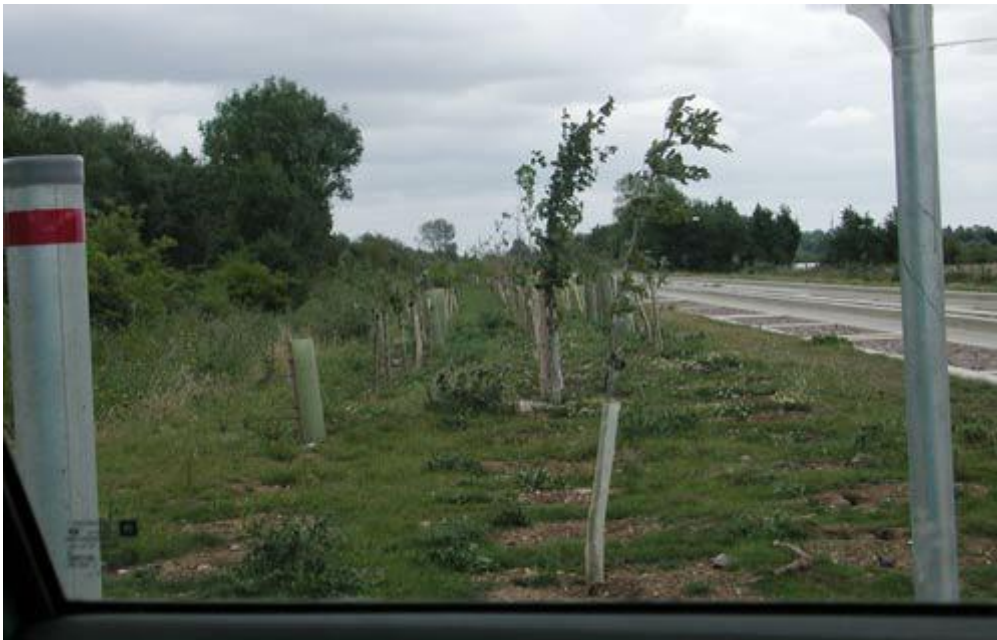
This is the view from the drivers seat with the car at the white line on the road.
